BELZONA REPAIRS CRACK ON ENGINE BLOCK

ID: 5270

Industry: *Pulp & Paper*
Application: *ENC-Engines and Casings*
Substrate: *Cast Iron*
Products: ** Belzona 1111 (Super Metal) ,*
** Belzona 9341 (Reinforcing Sheet) ,*

Customer Location: *Idaho, USA*
Application Date: *1992*

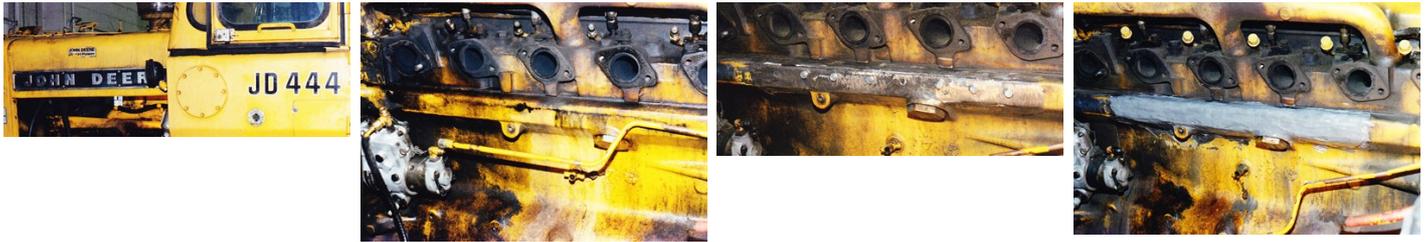
An early freeze allowed ice to crack the engine casing.

- * JD 444 Loader with cracked engine block ,
- * Engine showing long crack in water jacket ,
- * Area prepared with studs in place ,
- * Completed application ,

Cracked engine casing leaks antifreeze.

The application was carried out in accordance with Belzona Know-How System Leaflet ENC-1. The area was ground, studs placed every 2 inches then covered with Belzona 1111, incorporating Belzona 9341.
