BELZONA REPAIRS A 75-YEAR OLD VALVE FLAPPER

ID: 5350

Hydro Dam Check Valve Flapper

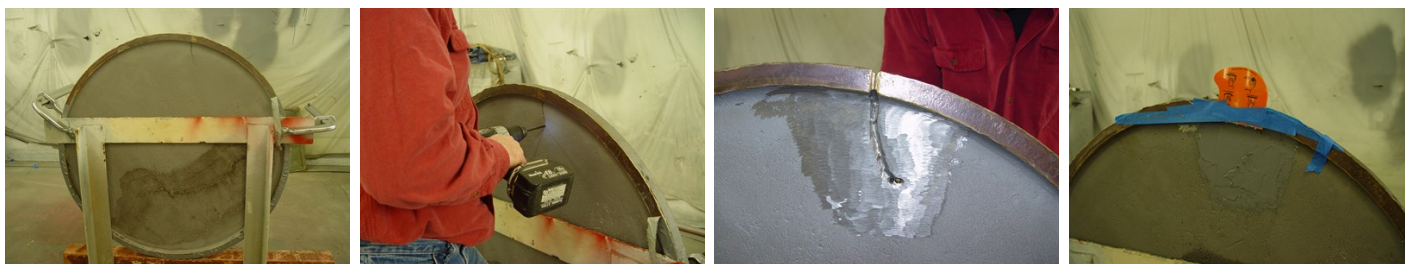
Cast Iron flapper disc had developed a crack. The check valve was 75 years old.

- * Flapper disc showing the crack at 1 o'clock. ,
- * Drilling the crack to place studs. ,
- * Area prepared, studs in place. ,
- * Belzona 1111 applied with reinforcement sheet, applicator taped in place to smooth the seal area. ,

The application was carried out in accordance with Belzona System Leaflet ENC-1. The plastic applicator was used to form the face in the seal area.
