# BELZONA REPAIRS A CRACKED ENGINE BLOCK

ID: 5366

John Deer engine block.

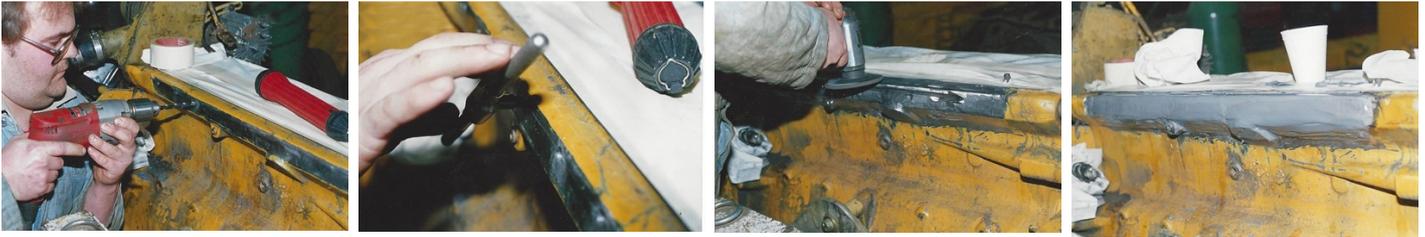
*Engine block cracked by freezing water.*

- \* Drilling holes along crack ,
- \* Threading holes ,
- \* Studs installed, grinding surface ,
- \* Reinforced Belzona 1111 applied to seal the crack ,

The only alternative was to replace the block. Instead, \$50.00 of Belzona 1111 was used to solve the problem.
