FLANGE REPAIR KEEPS PUMP GOING

ID: 5370

Customer Location: *Houston, Texas, USA*
Application Date: *November 2013*

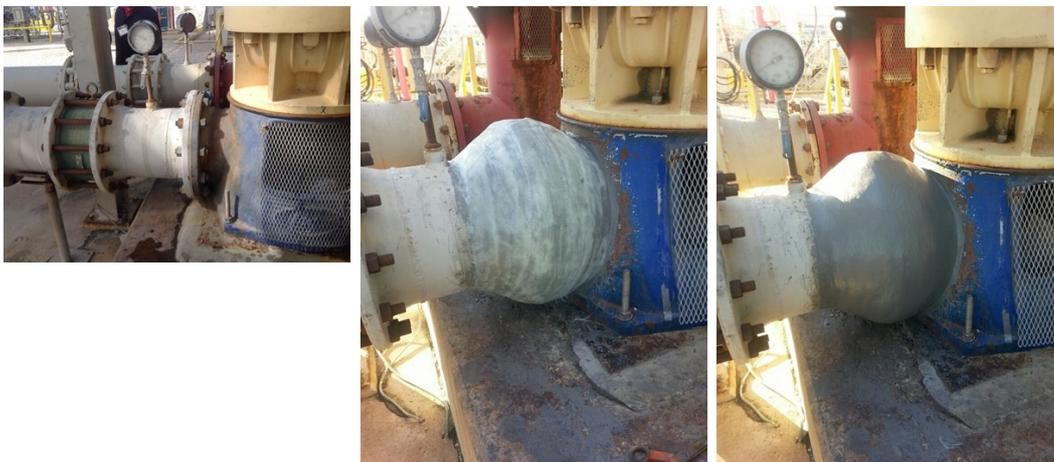
Customer could not pull the pump for the repair off the cracked flange and needed an in-place repair.

- * Overview of the pump and flange before the repair ,
- * Belzona 1121 used to build up the area and the composite wrap applied ,
- * Completed project ,

Cracked flange on cooling water pump.

The application was carried out in accordance to a modified version of Belzona Know-How System Leaflet VPF-11. A composite wrap using Belzona 1121 and Belzona 4151 with Belzona 9371 was used to encapsulate the flange.
