FLANGE REPAIR KEEPS PUMP GOING

ID: 5370

Customer Location: Houston, Texas, USA
Application Date: November 2013

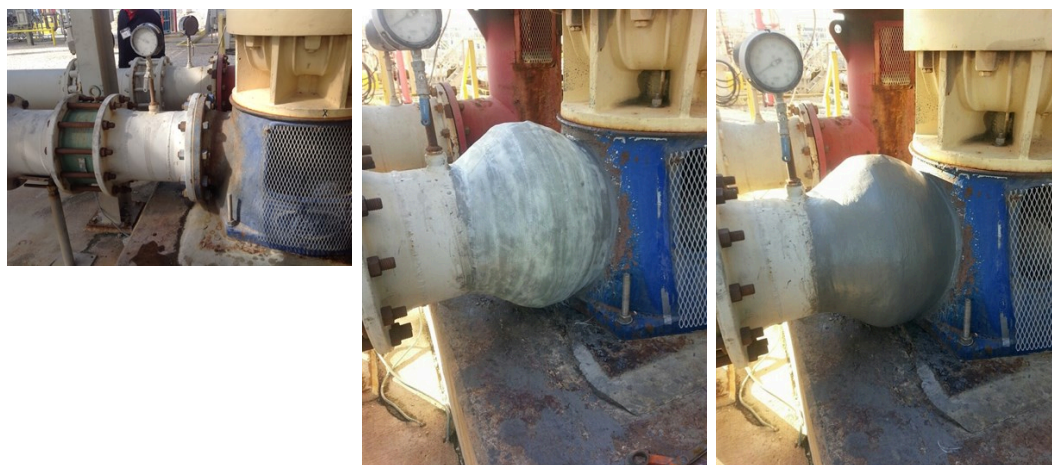
Customer could not pull the pump for the repair off the cracked flange and needed an in-place repair.

- * Overview of the pump and flange before the repair ,
- * Belzona 1121 used to build up the area and the composite wrap applied ,
- * Completed project ,

Cracked flange on cooling water pump.

The application was carried out in accordance to a modified version of Belzona Know-How System Leaflet VPF-11. A composite wrap using Belzona 1121 and Belzona 4151 with Belzona 9371 was used to encapsulate the flange.
