BELZONA REPAIRS DRILLING MACHINE THREAD

ID: 5411

Customer Location: Lynchburg, VA, USA
Application Date: July 2014

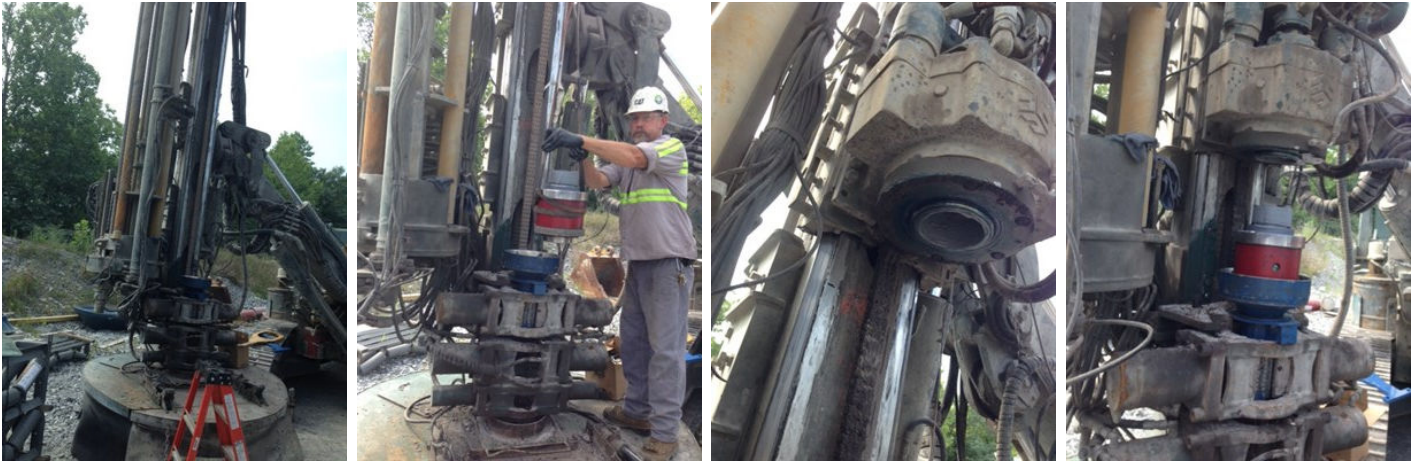
Worn threads on drilling machine would not allow the drill to seal properly, allowing water to leak and lose water pressure.

- * Overview of the drill ,
- * Male thread being placed underneath the female piece ,
- * Oversized female thread filled with Belzona 1111 ,
- * Belzona 1111 applied on male thread prior to placing both pieces together to complete the application ,

Threads on drilling machine were worn.

The threads were cleaned, using a suitable cleaner/degreaser and a wire brush on the female threads. A release agent was used on a new male thread piece. Belzona 1111 was mixed and applied to both male and female threads. The new piece was screwed into the worn female piece. The excess was wiped off and it was allowed to cure overnight. The new piece was removed in the morning, inspected and then screwed back and sealed. The drill has been constantly used for 2 months now and there are no signs of leakage.
