BELZONA REPAIR OF A SAND PUMP INCREASES SERVICE LIFE

ID: 5426

Customer Location: *South Louisiana, USA*
Application Date: *February 2014*

Substrate: *Cast iron*
Products: ** Belzona 1111 (Super Metal) ,*
** Belzona 1341 (Supermetalglide) ,*

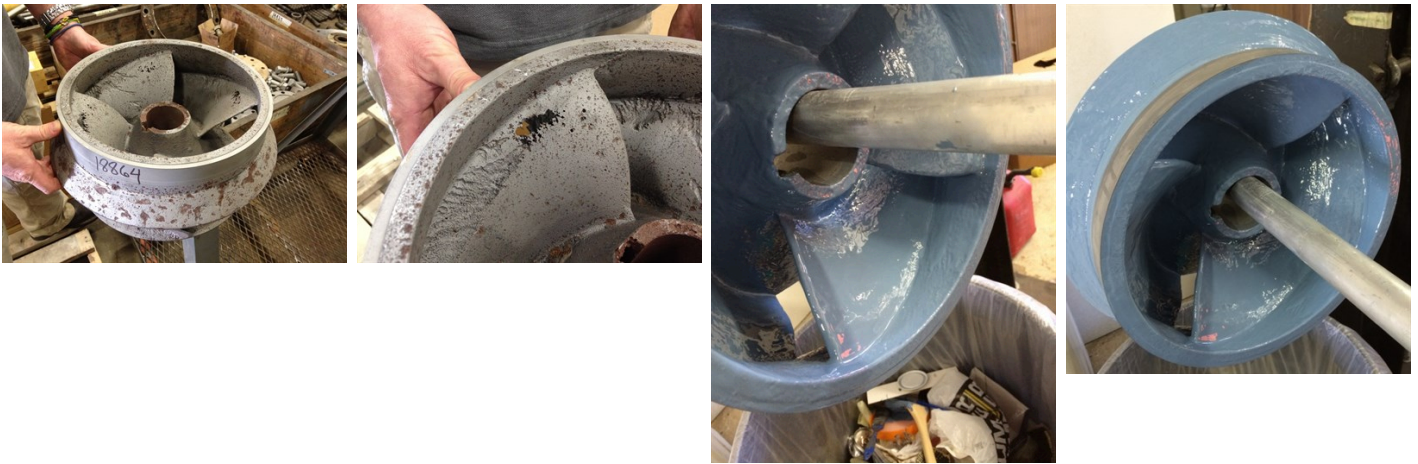
Due to high sand content in the water being pumped, impeller had holes and other areas of metal loss.

- * Impeller upon arrival ,
- * Holes and other visible damage to be repaired ,
- * Coated vanes ,
- * Impeller finished and ready to be re-installed in pump ,

Metal loss and holes in impeller vanes; pitting on outside of impeller.

The application was carried out in accordance with a modified version of Belzona Know-How System Leaflets CEP-1 and FBC-2
