# Belzona Pump Repair - From A to Z

ID: 543

Customer Location: Water Plant - Egypt  
Application Date: April 2005

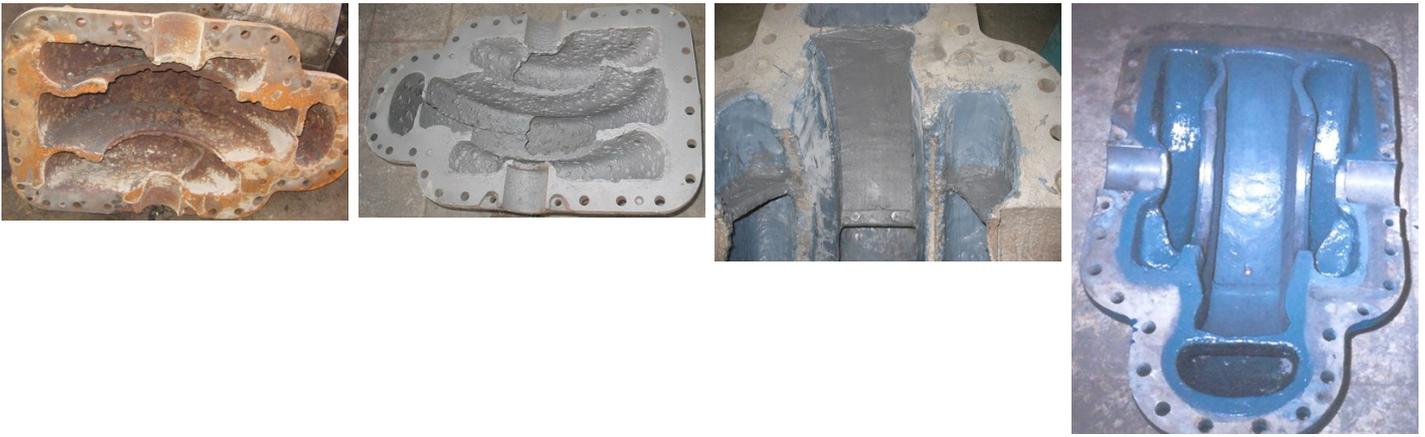
The pump casing, cut water, straighteners, wear ring and gland housing were all suffering from erosion-corrosion. Also, there was a long crack on the cut water.

- \* General view of the pump before repair. ,
- \* The pump after surface preparation. ,
- \* Crack of cutwater was repaired and the cutwater and the straighteners were rebuilt. ,
- \* Repair complete. Note how the seats and gland housing were perfectly repaired. ,

Application was carried out in accordance with Belzona Know-How System Leaflets CEP-1, CEP-2, CEP-3, CEP-5 and CEP-6.

Belzona repaired everything in the pump - from the casing to the cut water and straighteners, including repairing the wear ring seat

and the gland housing. In short Belzona returned this pump which was going to be junk to work again successfully saving the replacement costs of new pump and providing more resistance to the effects of erosion-corrosion than new one.
