Belzona Rebuilds Kiln Support Roller Shaft

ID: 544

Industry: General Industry
Application: MPT-Mechanical Power Transmission

Customer Location: Chemical manufacturer (Chromium)
Application Date: April 2005

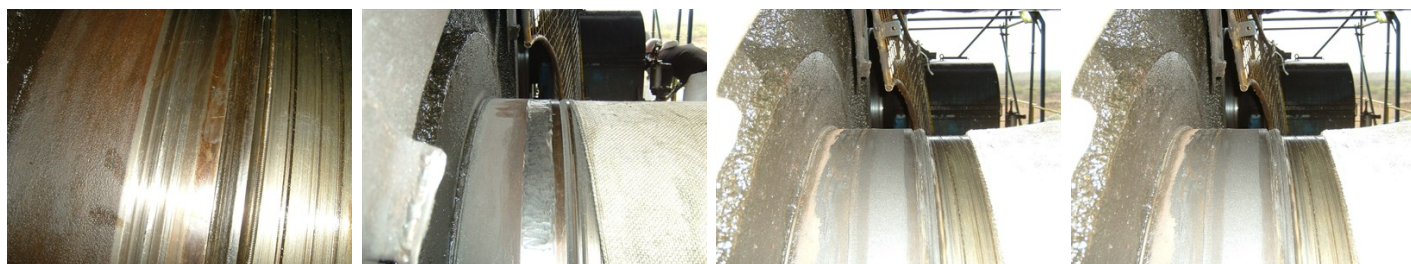
In service the shaft had become worn in the area where the lip seal ran. This allowed oil to leak past the seal resulting in the need for regular oil level checking and refilling as well as a serious slip hazard in the surrounding area.

- * Worn area of shaft ,
- * View of surface preparation ,
- * Completed repair ,
- * Close up of Belzona® 1131 repair ,

Worn seal area on kiln support roller shaft.

The application was carried out in accordance with a modified version of Belzona Know-How System Leaflet MPT-2. The repair was carried out in position. Only the top cradle was removed so application was carried out in two parts. After rebuilding top half, kiln was rotated 180° to allow lower half to be rebuilt.
