Belzona Rebuilds Kiln Support Roller Shaft

ID: 544

Customer Location: Chemical manufacturer (Chromium)
Application Date: April 2005

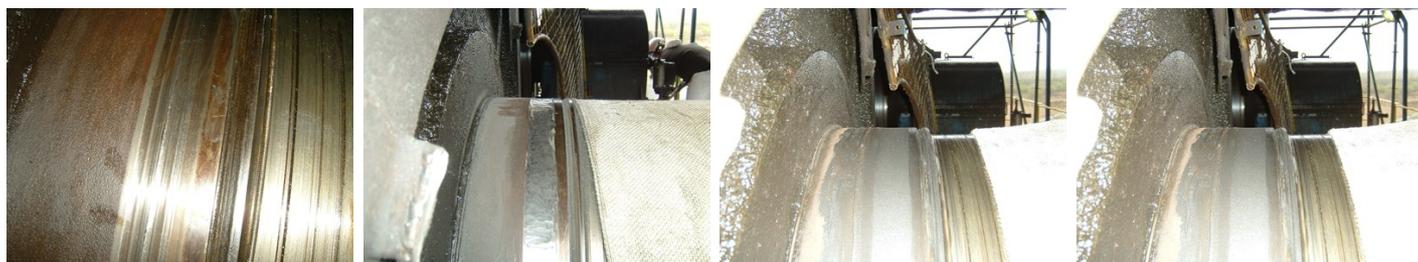
In service the shaft had become worn in the area where the lip seal ran. This allowed oil to leak past the seal resulting in the need for regular oil level checking and refilling as well as a serious slip hazard in the surrounding area.

- * Worn area of shaft ,
- * View of surface preparation ,
- * Completed repair ,
- * Close up of Belzona® 1131 repair ,

Worn seal area on kiln support roller shaft.

The application was carried out in accordance with a modified version of Belzona Know-How System Leaflet MPT-2. The repair was carried out in position. Only the top cradle was removed so application was carried out in two parts. After rebuilding top half, kiln was rotated 180° to allow lower half to be rebuilt.
