Offshore repair of a riser pipe

ID: 5462

12" T-pipe on an FPSO.

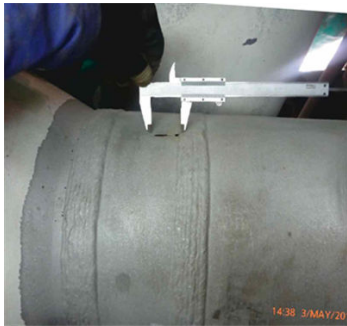
Cavitation near the flange, erosion between flange and T-section. Surface preparation created through-wall defects because of the thin remaining thickness of the pipe at some points.
