Offshore repair of a riser pipe

ID: 5462

Customer Location: Ivory Coast
Application Date: May 2014

12" T-pipe on an FPSO.

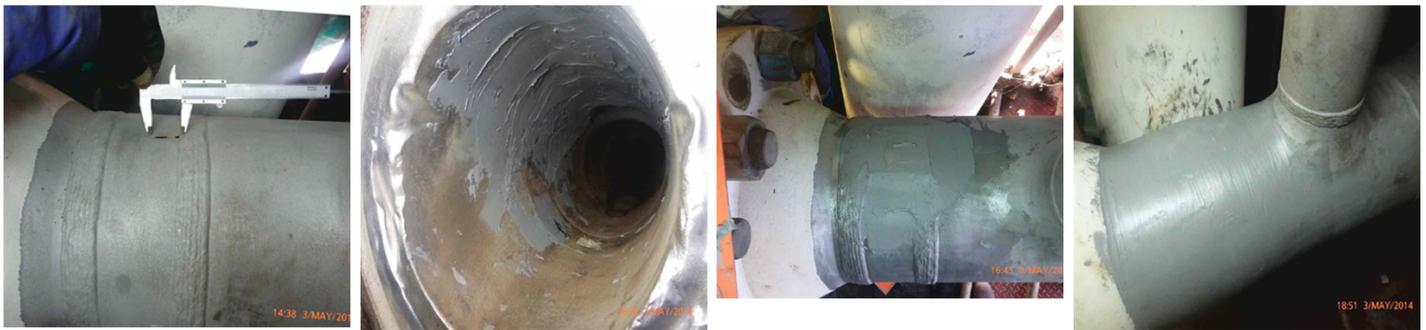
Cavitation near the flange, erosion between flange and T-section. Surface preparation created through-wall defects because of the thin remaining thickness of the pipe at some points.

- * Before repair ,
- * During internal application ,
- * External repair - plate bonding ,
- * Finished repair ,

In this case of emergency, an internal repair has been carried out first with Belzona 1121 in accordance with Belzona Know-How system leaflet VPF-1. Then a plate has been bonded on the through wall defect using the system leaflet VPF-11. To finish the repair, a reinforced wrap has been applied with Belzona 1121 and Belzona 9341. As the customer wanted a compliant repair, a Belzona SuperWrap system was designed and applied atop.
