BELZONA REPAIRS 8" WATER PIPE/FLANGE

ID: 5478

Industry: Power
Application: VPF-Valves, Pipes and Fittings
Substrate: Mild Steel and Concrete
Products: * Belzona 1121 (Super XL-Metal) ,
* Belzona 1321 (Ceramic S-Metal) ,

Customer Location: Anadarko, Oklahoma
Application Date: October 2014

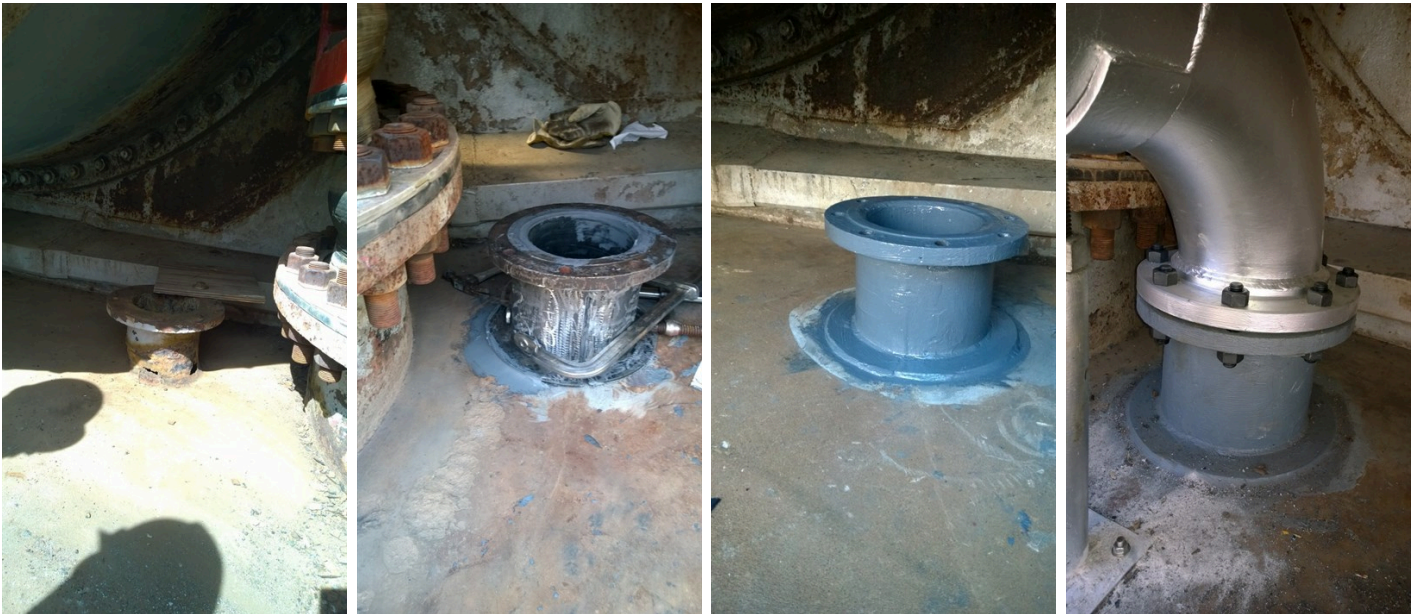
8" pipe had corroded all the way through the pipe in several areas around it. The heat condensers were installed directly above the flange and the pipe that returned cooled water back into the plant. There was not a lot of room to work with and the customer did not know how to seal or repair. They wanted a solution that would prevent the pipe from seperating at the concrete level.

- * 8" pipe/flange in existing condition ,
- * Cold bonding process with Belzona 1121 to the interior and exterior sleeve ,
- * Two coats of Belzona 1321 on interior and exterior ,
- * Completed application and back in service ,

Corrosion was removed through grinding and the interior sleeve was then cold bonded with Belzona 1121. The voided areas and rough edges were then filled in with Belzona 1121 around the interior sleeve. The exterior sleeve to the 8" pipe and the concrete was cold bonded with Belzona 1121. Two coats of Belzona 1321 were applied on the interior and exterior.
