BELZONA REPAIRS 8" WATER PIPE/FLANGE

ID: 5478

Customer Location: Anadarko, Oklahoma
Application Date: October 2014

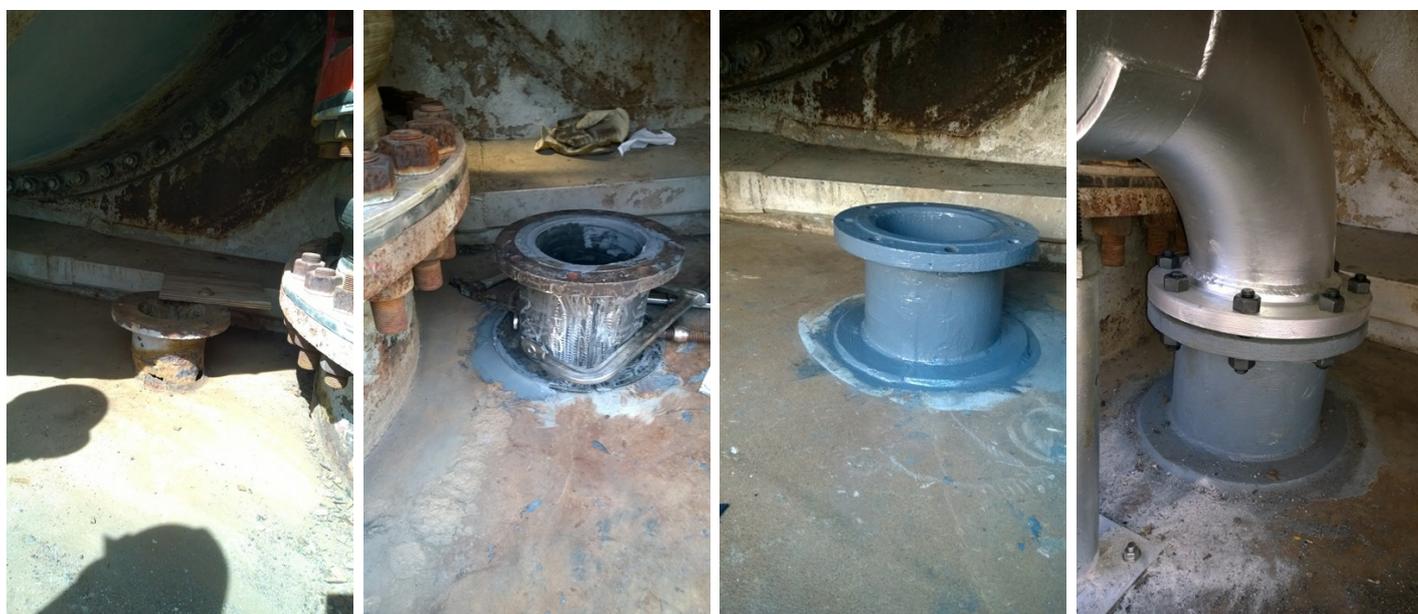
8" pipe had corroded all the way through the pipe in several areas around it. The heat condensers were installed directly above the flange and the pipe that returned cooled water back into the plant. There was not a lot of room to work with and the customer did not know how to seal or repair. They wanted a solution that would prevent the pipe from seperating at the concrete level.

- * 8" pipe/flange in existing condition ,
- * Cold bonding process with Belzona 1121 to the interior and exterior sleeve ,
- * Two coats of Belzona 1321 on interior and exterior ,
- * Completed application and back in service ,

Corrosion was removed through grinding and the interior sleeve was then cold bonded with Belzona 1121. The voided areas and rough edges were then filled in with Belzona 1121 around the interior sleeve. The exterior sleeve to the 8" pipe and the concrete was cold bonded with Belzona 1121. Two coats of Belzona 1321 were applied on the interior and exterior.
