BELZONA REPAIRS TO CREAMERY MILK RECEPTION FLOOR AREA

ID: 5549

Customer Location: Creamery, Stranraer, Scotland
Application Date: November 2014

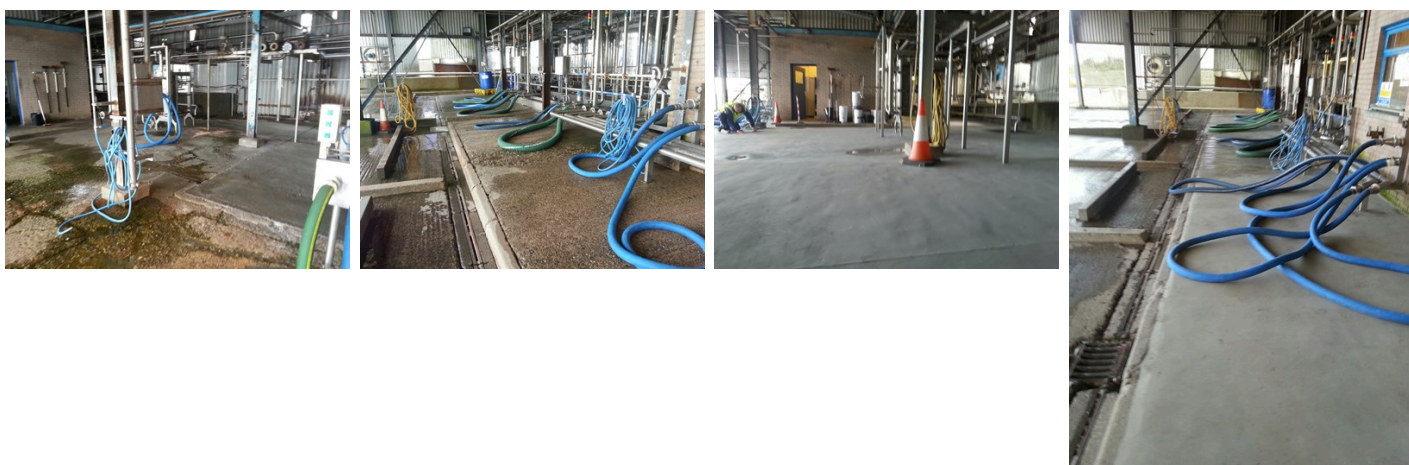
The materials had to be applied and cured in this short time frame. Over the years, the concrete floor had deteriorated due to wear, abrasion and chemical attack from the milk and cleaning fluids used. In some areas, the concrete has become cracked, and in others, it has worn down resulting in an uneven surface. An expansion joint was also in need of replacement.

- * Cracks in the concrete floor ,
- * Damage from loading product ,
- * Application of Belzona 4131 ,
- * Completed application ,

The area was mechanically prepared and power washed to bring out any ingrained chemicals. The application was carried out in accordance with Belzona Know-How System Leaflets FPA-1 and FPA-6.

Digging out the entire area and replacing it with concrete would have taken longer than the shutdown allowed. Additionally, it would have caused disruption to the work carried out around the area. Belzona 4131 provides a hard wearing chemical resistant surface.
