Belzona Repairs Loose Wear Ring

ID: 555

Customer Location: Power plant - Egypt
Application Date: February, 2003

Wear ring in main cooling water pump

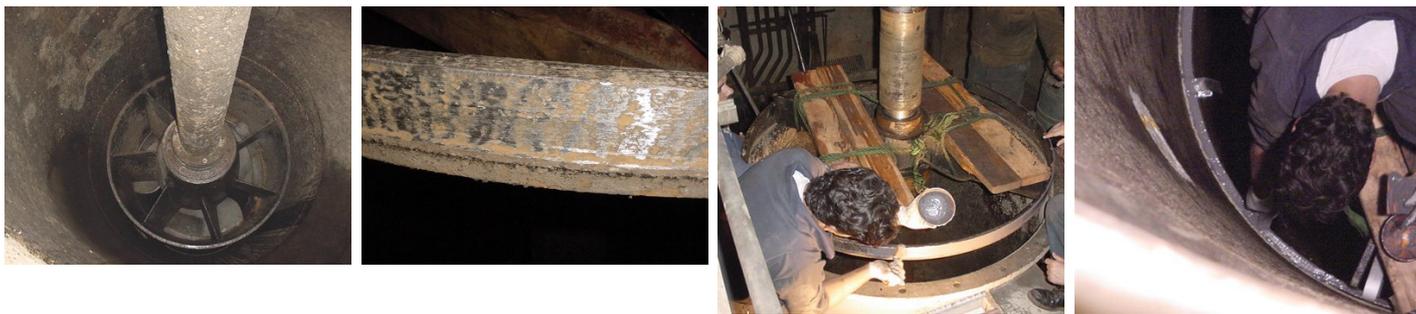
Ring had become loose in its housing.

- * General view of the pump ,
- * Corrosion caused wear at the ring ,
- * Application of the first layer of Belzona® 1321 ,
- * Removing excess material after injecting the second layer of Belzona® 1321 ,

Application was carried out in accordance with modified version of Belzona® Know-How System Leaflet CEP-2.
