Repair of the damaged motorcycle fork cover KTM

ID: 5575

Customer Location: *Oraving Slovnaft Team, Slovakia*
Application Date: *2015 January*

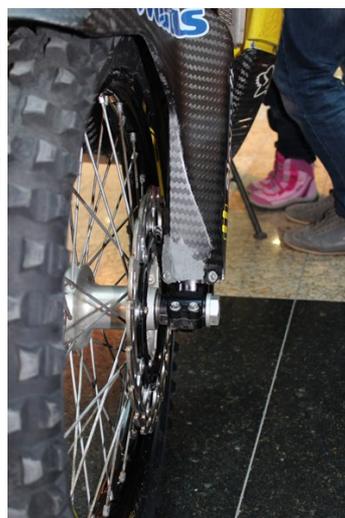
Slovak rider (supported by Belzona products) with escort repair truck - fifth overall bike on the Dakar rally 2015

Repairs in the field conditions

Application was carried out in accordance with Belzona Know-How System Leaflet ENC-1 in field conditions. The cover was dismantled, ragged by steel brush, cleaned and recovered with Belzona 1221 together with Belzona 9341.

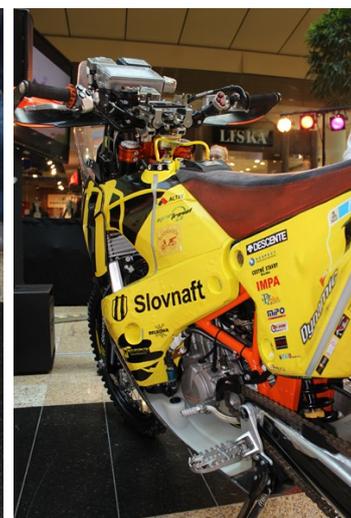
“Emergency” repair of the damaged motorcycle fork cover KTM hold for the all race (photo from after rally promotion show)

Motorcycle KTM - after rally promotion show
