# BELZONA ENGINE BLOCK REPAIR AND PROTECTION

ID: 572

**Customer Location:** Iron and steel manufacturing factory,  
Egypt

**Application:** ENC-Engines and Casings

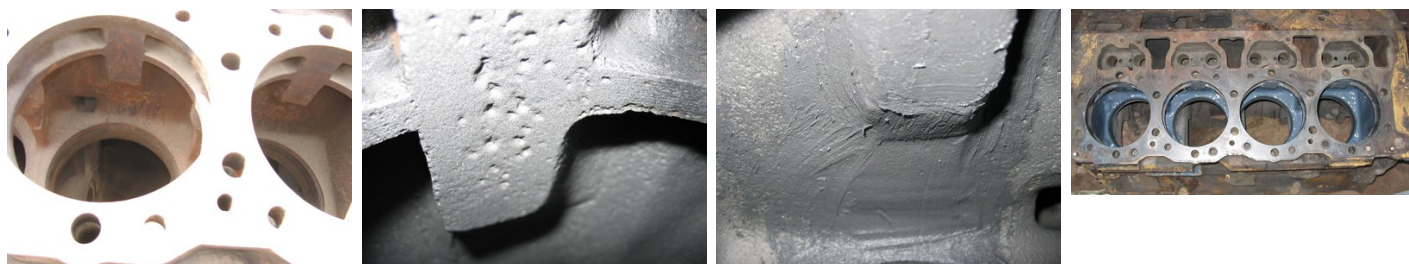
Cavitation and corrosion in water passages of engine block.

- \* General view of the block ,
- \* Cavitation area after blasting ,
- \* Rebuilding cavitation area using Belzona® 1311 (Ceramic R-Metal) ,
- \* Applying Belzona® 1391 (Ceramic-HT) to the block ,

Application was carried out in accordance with Belzona Know-How System Leaflet ENC-6.

This is a routine repair on engine blocks as cavitation is a common problem in this area of the engine.
