BELZONA SEALED THE LOCK

ID: 5758

Industry: Power
Application: FPA-Floor Problem Areas
Substrate: Concrete
Products: * Belzona 4111 (Magma-Quartz),

Customer Location: Dam, Oklahoma, USA
Application Date: 2004

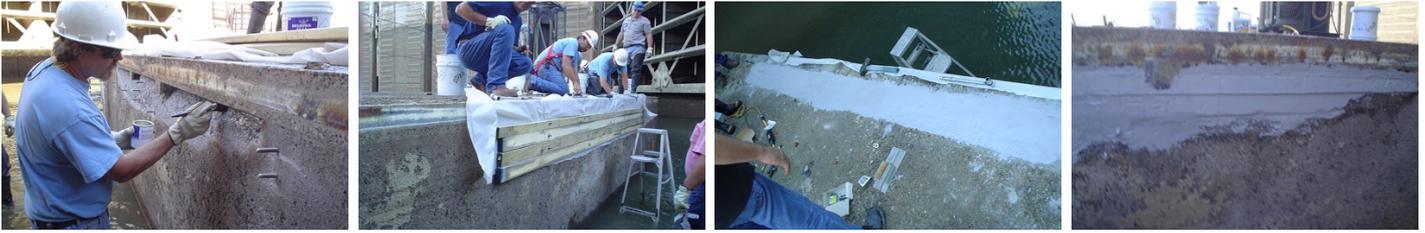
Damaged concrete below the seal plate let water leak into the lock.

- * Lumber placed in the lock ,
- * Belzona 4111 built up damaged area ,
- * Completed repair top view ,
- * Completed repair side view ,

The application was carried out in accordance with Belzona Know-How System Leaflet FPA-1. 16 foot 2x4's were drilled and put into place on the dam. Plastic was used as a release agent and the void was filled with Belzona 4111.
