BELZONA SEALED THE LOCK

ID: 5758

Customer Location: Dam, Oklahoma, USA
Application Date: 2004

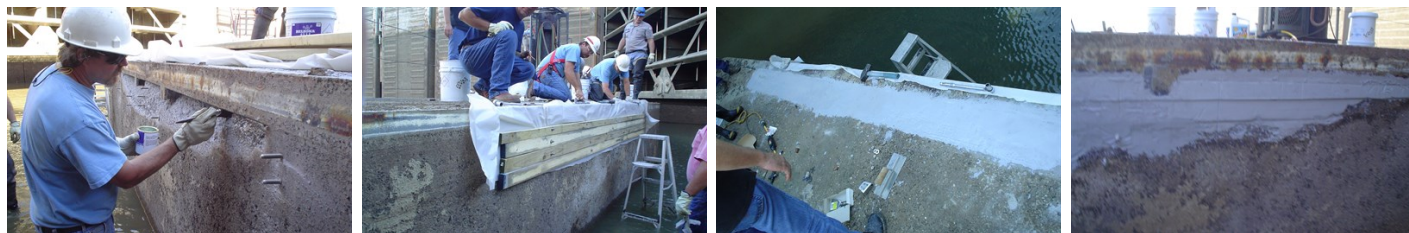
Damaged concrete below the seal plate let water leak into the lock.

- * Lumber placed in the lock ,
- * Belzona 4111 built up damaged area ,
- * Completed repair top view ,
- * Completed repair side view ,

The application was carried out in accordance with Belzona Know-How System Leaflet FPA-1. 16 foot 2x4's were drilled and put into place on the dam. Plastic was used as a release agent and the void was filled with Belzona 4111.
