BELZONA FULLY SEALS FLANGE BETWEEN KAPLAN TURBINE AND SPIRAL CASING

ID: 5846

Customer Location: Hydropower Station, Aschbach, Austria
Application Date: July/August 2010

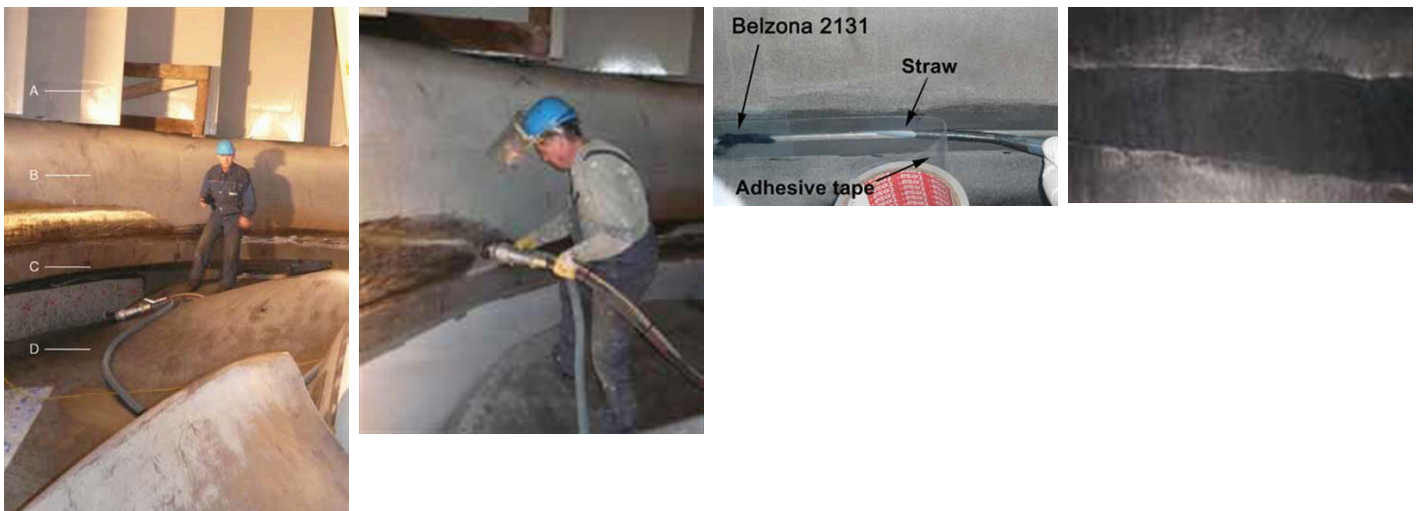
A new larger turbine runner, which has recently been built to increase the turbine output, required the installation of a new turbine casing that required welding. The heat generated from this process caused the turbine casing to become distorted and a circumferential gap of between 2.8 mm to 4.6 mm appeared between the two mating flanges.

- * View of the Kaplan Turbine; A) stay vanes, B) spiral casing, C) circumferential gap, D) turbine runner output, 85 MW ,
- * Surface preparation with the dust-free vacu-blast system ,
- * Tape used to prevent overflow and to ensure gap was fully injected with Belzona 2131 ,
- * Completed repair with Belzona 2131 on inside section of gap ,

The surface in and around the gap was prepared by grit blasting to ensure a minimum profile depth of 90 microns. The next step was to insert a foam backer rod into the gap to prevent Belzona 2131 from flowing into the outer section. In order to achieve the best adhesion possible, the surfaces had to be pre-treated with Belzona 2941. The injection nozzle was elongated with a flexible straw to ensure that Belzona 2131 could be injected into even the smallest area. The injection method was carried out and after cure, which in this case needed three-and-a-half days, the tape was removed and Belzona 2131 was faired level to the metal surface. The outer gap was then prepared for the injection of Belzona 1321. 96 bolt holes were injected with Belzona 1321 and the edge was then sealed with Belzona 1111 to ensure no overflow would occur. The bolt was treated with Belzona 9411 which ensured that the bolt could be removed easily after curing. Once fully cured, the release agent bolts were replaced by the originals and the flanges could be mated together without unnecessary stressing and the casing joint was now fully sealed.
