# BELZONA FULLY SEALS FLANGE BETWEEN KAPLAN TURBINE AND SPIRAL CASING

ID: 5846

Customer Location: Hydropower Station, Aschbach, Austria  
Application Date: July/August 2010

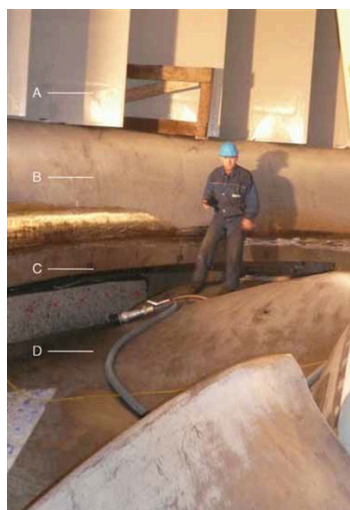
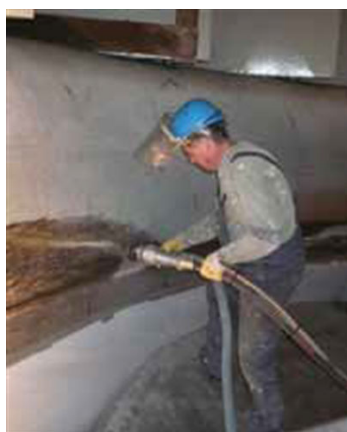
A new larger turbine runner, which has recently been built to increase the turbine output, required the installation of a new turbine casing that required welding. The heat generated from this process caused the turbine casing to become distorted and a circumferential gap of between 2.8 mm to 4.6 mm appeared between the two mating flanges.

- \* View of the Kaplan Turbine; A) stay vanes, B) spiral casing, C) circumferential gap, D) turbine runner output, 85 MW ,
- \* Surface preparation with the dust-free vacu-blast system ,
- \* Tape used to prevent overflow and to ensure gap was fully injected with Belzona 2131 ,
- \* Completed repair with Belzona 2131 on inside section of gap ,

The surface in and around the gap was prepared by grit blasting to ensure a minimum profile depth of 90 microns. The next step was to insert a foam backer rod into the gap to prevent Belzona 2131 from flowing into the outer section. In order to achieve the best adhesion possible, the surfaces had to be pre-treated with Belzona 2941. The injection nozzle was elongated with a flexible straw to ensure that Belzona 2131 could be injected into even the smallest area. The injection method was carried out and after cure, which in this case needed three-and-a-half days, the tape was removed and Belzona 2131 was faired level to the metal surface. The outer gap was then prepared for the injection of Belzona 1321. 96 bolt holes were injected with Belzona 1321 and the edge was then sealed with Belzona 1111 to ensure no overflow would occur. The bolt was treated with Belzona 9411 which ensured that the bolt could be removed easily after curing. Once fully cured, the release agent bolts were replaced by the originals and the flanges could be mated together without unnecessary stressing and the casing joint was now fully sealed.
