BELZONA AVOIDS LONGER DOWNTIME

ID: 5897

Industry: Power
Application: FBC-Fans, Blowers and Compressors

Francis turbine cone.

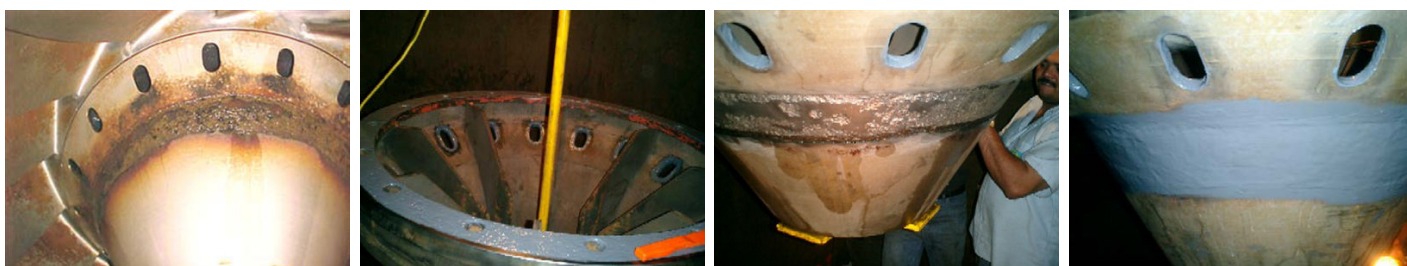
Wear on the flange caused sealing problems and erosion/corrosion on the cone's border. Total disassembly of the unit would cause a longer downtime.

- * Damage on cone ,
- * Damage on flange and application of Belzona 1321 ,
- * Cleaning and refilling with Belzona 1311 ,
- * Protected with Belzona 1321 ,

The application was carried out in accordance with Belzona Know-How System Leaflet FBC-5 and FBC-2.

The conventional solution required total disassembly of the unit with a long wait period and a high cost abroad, the Belzona solution was applied in situ and in 4 hours.
