BELZONA AVOIDS LONGER DOWNTIME

ID: 5897

Industry: Power
Application: FBC-Fans, Blowers and Compressors

Francis turbine cone.

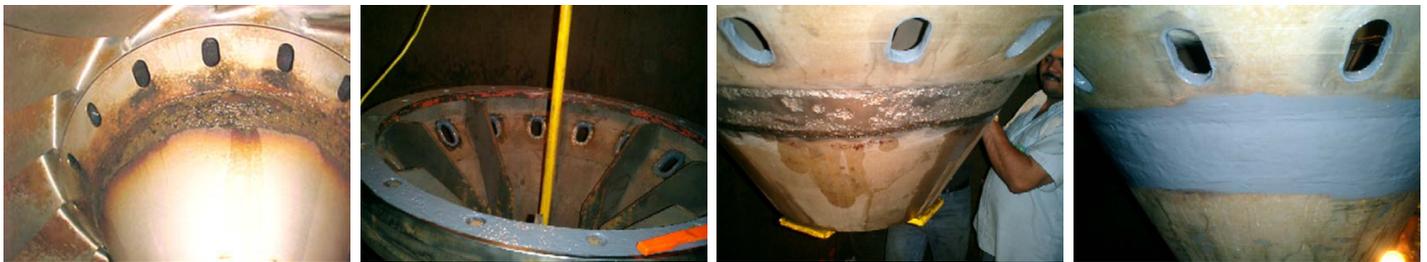
Wear on the flange caused sealing problems and erosion/corrosion on the cone's border. Total disassembly of the unit would cause a longer downtime.

- * Damage on cone ,
- * Damage on flange and application of Belzona 1321 ,
- * Cleaning and refilling with Belzona 1311 ,
- * Protected with Belzona 1321 ,

The conventional solution required total disassembly of the unit with a long wait period and a high cost abroad, the Belzona solution was applied in situ and in 4 hours.
