# BELZONA REPAIRS BROKEN FLANGE

ID: 5922

Industry: Fluid Flow

Substrate: Cast iron

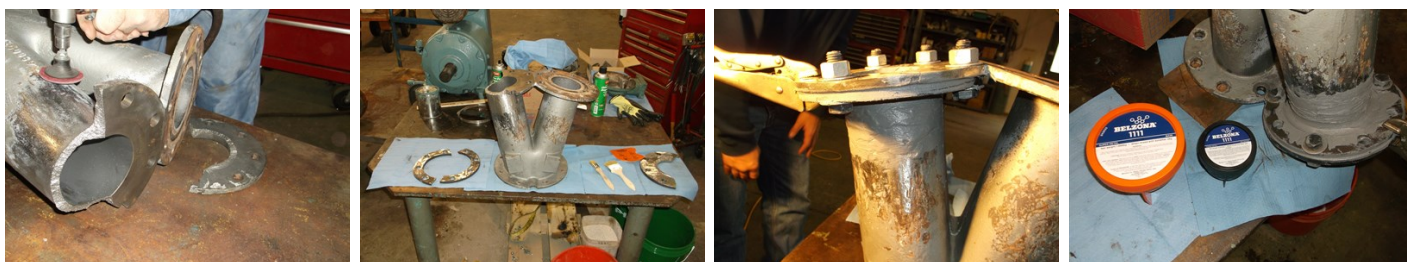
Broken flange collar was causing material to spill out when in operation.

- \* View of the broken flange and removing paint to prepare surface ,
- \* Broken flange in the center, broken piece to the right and the steel backers to the left, ready for the application ,
- \* Side view of completed repair ,
- \* Top view of completed flange repair ,

The flange had evidence of rubberized materials around the break, and was currently covered under a mountain of tape and plastic sheeting in an attempt to contain the leaking material. The only other alternative was replacement and due to the nature of the piece, that was not a viable option. A rough total of \$40.00 USD of Belzona 1111, Belzona 9341 and Belzona 9411 was used and provided a longer than expected repair. The application also allowed the pipeline to return to operation in a very minimal time frame.

A 2-piece steel backer was built to bond to the broken flange for added strength. A grinder was used to roughen the application surface. It was then thoroughly cleaned and Belzona 9411 was applied to the bolts, washers, and nuts. A part of Belzona 9341 was pre-cut. A thin coat of Belzona 1111 was applied to all application surfaces and onto Belzona 9341. The application started by wrapping Belzona 9341 around the shoulder of the flange and then the broken piece was mounted back onto the flange using the steel backers. For a finished fit, the bolts were tightened down. Then, the remainder of Belzona 1111 was applied over Belzona 9341.
