BELZONA SAVES THE BULL GEAR

ID: 5924

Ore processing Ball Mill bull gear.

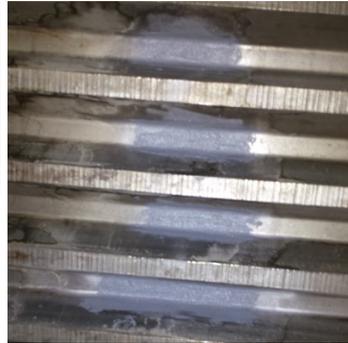
The gears on this Ball Mill bull gear were experiencing erosion and pitting.

If unchecked, the erosion damage could have weakened the bull gear, forcing the need to replace it. There are a total of 5 of these gears with damage and they were manufactured in the 1960's. The replacement cost is estimated at \$150,000.00 USD each and

The application area was thoroughly cleaned with solvent and then grit blasted to prepare the surface. All erosion damage was filled in with Belzona 1111 and followed with a brush on coating of Belzona 1321 to protect against further damage.
