BELZONA SAVES THE BULL GEAR

ID: 5924

Industry: *Mining & Quarrying*
Application: *MPT-Mechanical Power Transmission*

Ore processing Ball Mill bull gear.

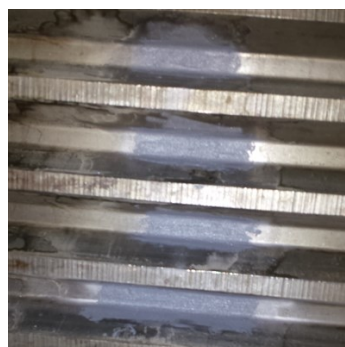
The gears on this Ball Mill bull gear were experiencing erosion and pitting.

- * 1 of 5 Ball Mills. ,
- * Erosion damage cleaned and grit blasted. ,
- * Application of Belzona 1111. ,
- * Application of Belzona 1321. ,

The application area was thoroughly cleaned with solvent and then grit blasted to prepare the surface. All erosion damage was filled in with Belzona 1111 and followed with a brush on coating of Belzona 1321 to protect against further damage.
