CENTRIFUGAL PUMP REPAIRED AT A FRACTION OF THE COST OF REPLACEMENT

ID: 6034

Customer Location: *Louisiana, USA*
Application Date: *July, 2015*

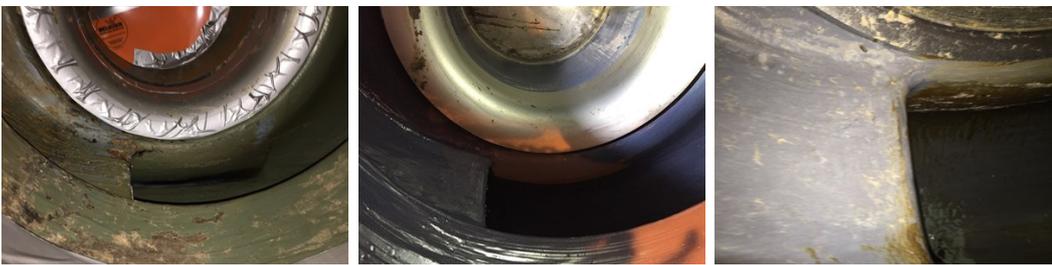
Badly damaged pump casing internals with pitting could not be removed and replaced or put back in service.

- * Corroded and damaged pump before application. ,
- * Pump casing coated with Belzona 1331. ,
- * Pump casing seven months after the application. This time instead of coating or replacing, the plant inspected and returned to service with little to no down time. ,

The application was carried out in accordance with a modified version of the Belzona Know-How System Leaflet CEP-5.

In the past the pump casing would be scrapped and replaced at a cost of \$36,000, providing only three to six months of service. The Belzona repair cost \$10,000, saving \$26,000 in replacement costs and preventing extra downtime in the future.
