BELZONA PRESERVES 60-YEAR-OLD WATER PUMP FOR IRRIGATION DISTRICT

Application: CEP-Centrifugal Pumps

Application Date: May 2015

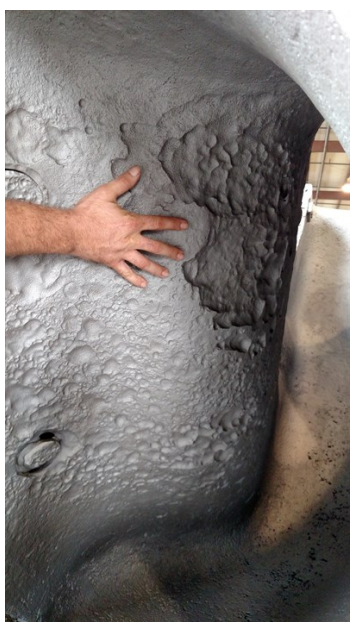
Flanges on the split line, wear ring fits, and packing areas were severely corroded, preventing the pump from sealing and made it very inefficient.

- * Severe corrosion in body of the pump ,
- * Close up of screws installed ,
- * Screws installed in split line and wear rings ,
- * Completed application to pump case ,
