BELZONA SAVES CAST IMPELLER FROM SCRAP

ID: 6423

Industry: General Industry
Application: CEP-Centrifugal Pumps
Substrate: Cast Iron
Products: * Belzona 1311 (Ceramic R-Metal) ,

Customer Location: Mechanical Workshop, Bulgaria
Application Date: March, 2016

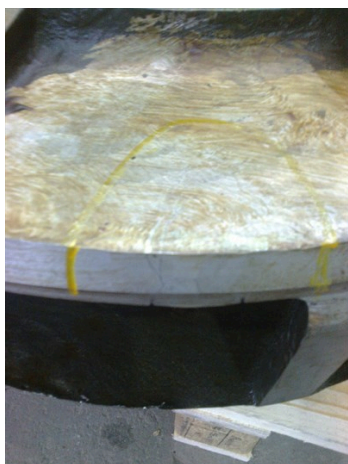
Set of cracks on one side of the newly cast impeller. The end-user had refused to accept the impeller without elimination of the cracked area. After mutual agreement between the customer and end-user, they agreed that a Belzona solution could be used.
