BELZONA REPAIRS SHIPS GENERATOR AFTER WELD REPAIR FAILS

ID: 651

Customer Location: *Cruise Line, Port Everglades, Florida*
Application Date: *November 2005*

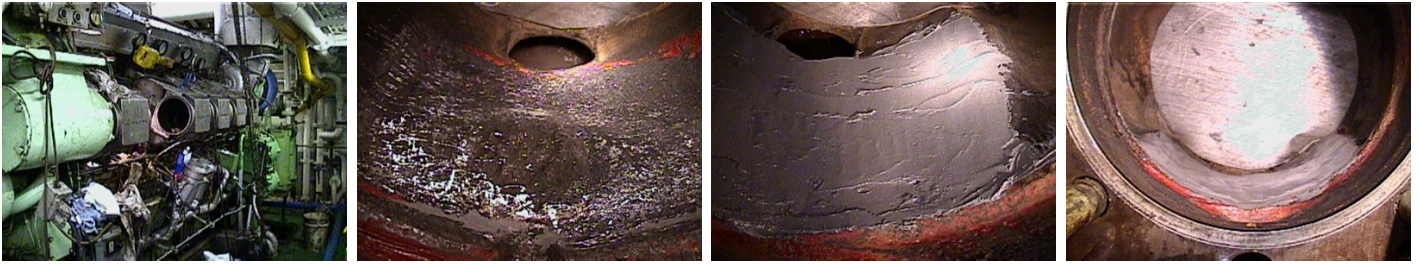
Damaged generator casing allowing coolant into main sump threatening ships main engine bearings.

- * Generator with cylinder removed ,
- * Surface surrounding failed weld roughened ,
- * Belzona® 1111/9341 patch applied over weld repair and extended onto surrounding area ,
- * Final repair smoothed out and awaiting Infrared lamp to accelerate cure ,

Main generator oil sump which is shared with ships main engine. Initial weld repair failed.

Classic failure of welding cast iron. Ship sails nightly but re-work completed in 5 hours keeping ship on schedule at full power. Customer is delighted with Belzona!

Application carried out in accordance with Belzona Know-How System Leaflet ENC-1. Particular attention paid to removing all substrate contamination using solvent washing and heat.
