BELZONA REPAIR TO LARGE EXCAVATOR CONTROL CABLE

ID: 662

Customer Location: *Ferro-nickel plant in Macedonia*
Application Date: *June 2003*

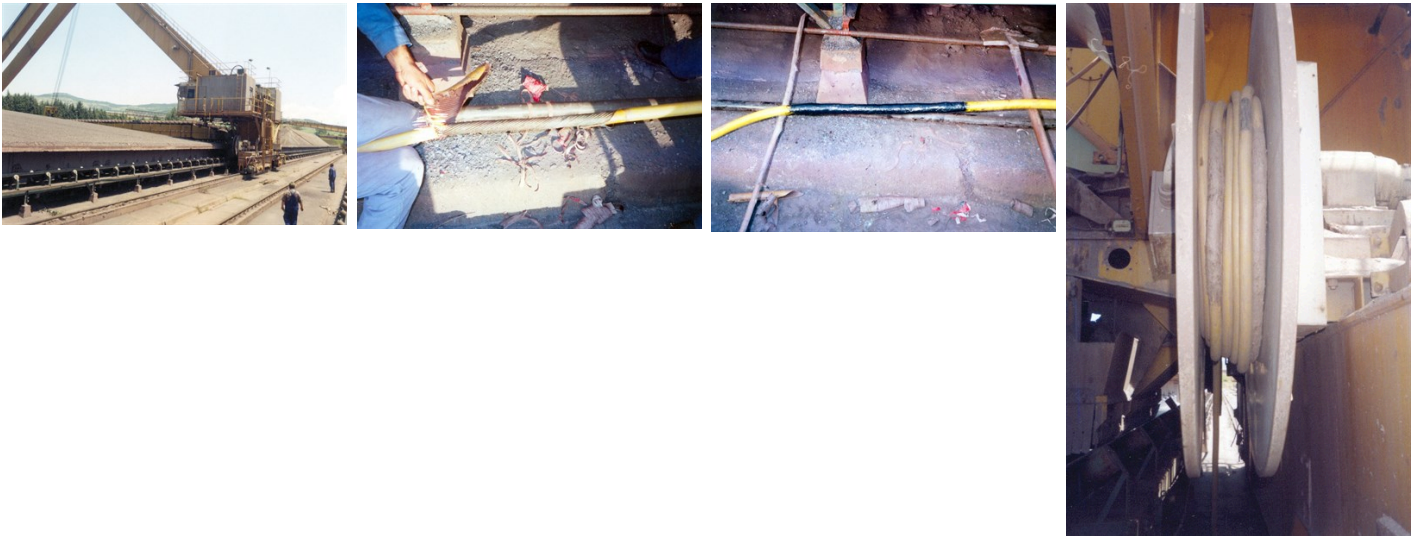
Torn cable cover due to weather influences and friction with ground. There was need for material which is elastic, has good adhesion, abrasion and water resistance.

- * View of excavator ,
- * Torn cable cover ,
- * Repaired cable with Belzona® 2311 ,
- * Condition after 14 months in service ,

Control cable from large iron ore excavator.

Application was carried out in accordance with Belzona Know-How System Leaflet ENC-10. Belzona® 9341 (Reinforcement tape) was used between two layers of Belzona® 2311

Mechanical bonded rubber coupling had been used before on damaged insulation of the cable, but Belzona® 2311 showed better elasticity, adhesion and abrasion resistance. This application have been done on ten further locations.
