# BELZONA REPAIRS OIL LEAKS ON WIND FARM TRANSFORMER

ID: 7535

Customer Location: Ireland  
Application Date: September 2017

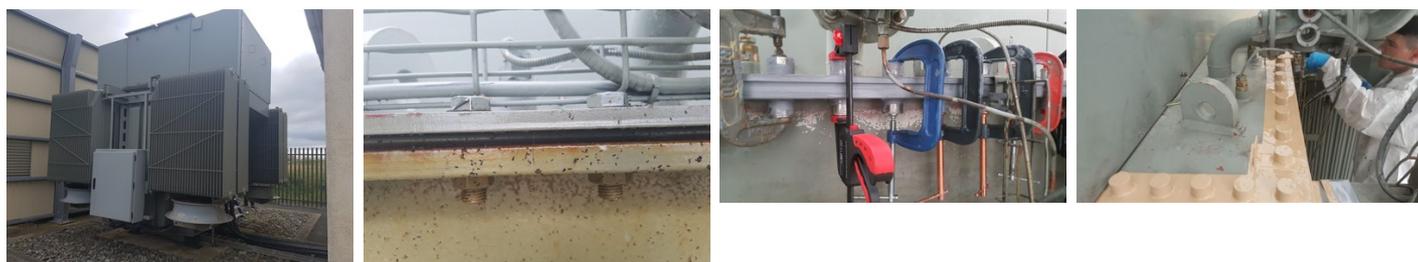
- \* 1. General view of the transformer ,
- \* 2. Leaking oil on the flange ,
- \* 3. Flange face filled with Belzona 1161 and caps installed ,
- \* 4. Completed section ,

Transformer for a wind farm was leaking oil through the main flange and flange bolt holes. Approximately 120 bolts were leaking.

Application was carried out in accordance with a modified version of Belzona Know-How System Leaflet GSS-8. Stainless steel caps were fabricated to fit over the bolt heads and the nuts. The gap in between the transformer body and the top cover was filled with Belzona 1161. The caps were filled with Belzona 1161 and clamped onto the bolt heads and nuts. The repair was coated with Belzona 5811
