# Belzona repairs damaged turbine flange face

Customer Location: Chemical plant, Slovakia

Application: ENC-Engines and Casings

Split casing of steam turbine.

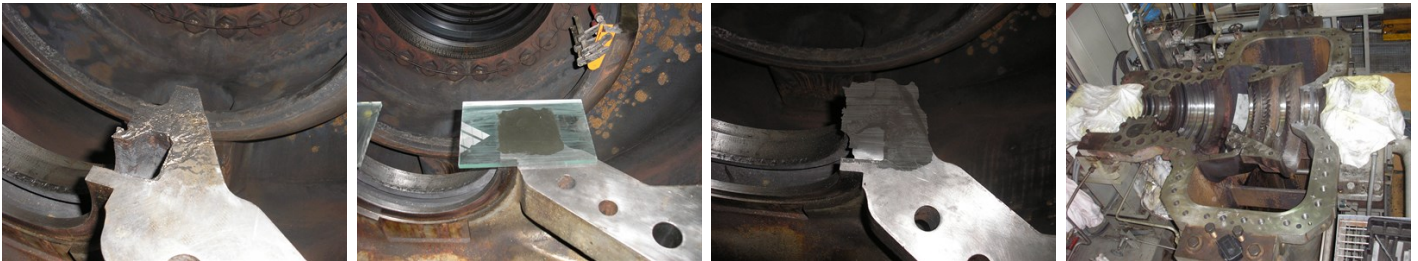
Wet steam caused erosion corrosion damage to flange face of turbine casing. This damage meant steam leakage from the turbine.

- \* 1. Damaged turbine split casing ,
- \* 2. Glass panel (coated with Belzona 9411 Release agent)used to form flat surface on Belzona ,
- \* 3. Repaired area ,
- \* 4. Turbine ready for mounting ,

Application was carried out in accordance with Belzona Know-How System Leaflet ENC-7.

Disconnecting, montage and transport would be very expensive for customer. Belzona repair is very quick and minimized outage of the turbine.
