Belzona repairs damaged turbine flange face

ID: 7570

Split casing of steam turbine.

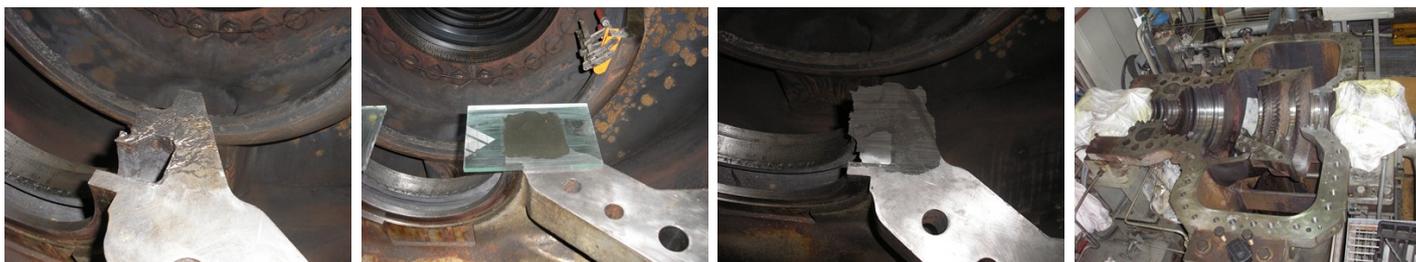
Wet steam caused erosion corrosion damage to flange face of turbine casing. This damage meant steam leakage from the turbine.

- * 1. Damaged turbine split casing ,
- * 2. Glass panel (coated with Belzona 9411 Release agent)used to form flat surface on Belzona ,
- * 3. Repaired area ,
- * 4. Turbine ready for mounting ,

Application was carried out in accordance with Belzona Know-How System Leaflet ENC-7.
