Lorry Engine Repaired with Belzona

ID: 7576

Customer Location: *Transport company, Slovakia*
Application Date: *2014*

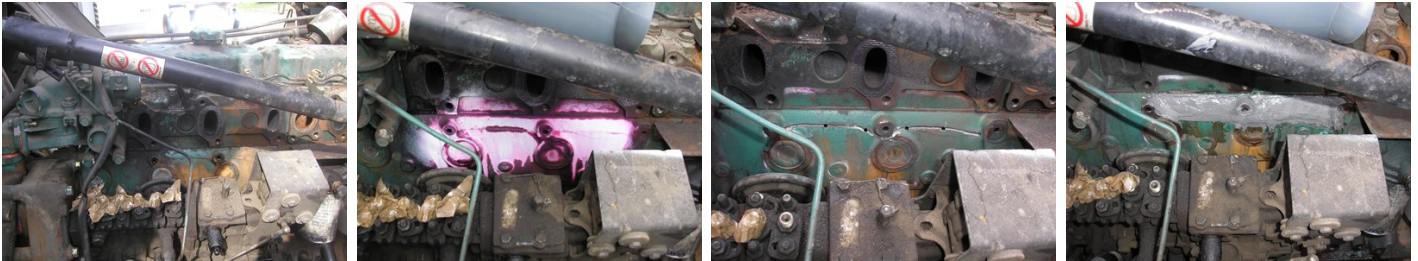
Cracked block due to freezing over winter months.

- * 1. Cracked engine ,
- * 2. Crack detection to identify all cracks ,
- * 3. Surface preparation ,
- * 4. Belzona 1111 repair incorporating Belzona 9341 Reinforcement Tape. ,

Application was carried out in accordance with Belzona Know-How System Leaflet ENC- 1

Welding of this damage would take a long time and potentially cause more damage so repairing with Belzona 1111 was much better for customer.
