# Lorry Engine Repaired with Belzona

ID: 7576

Customer Location: *Transport company, Slovakia*  
Application Date: *2014*

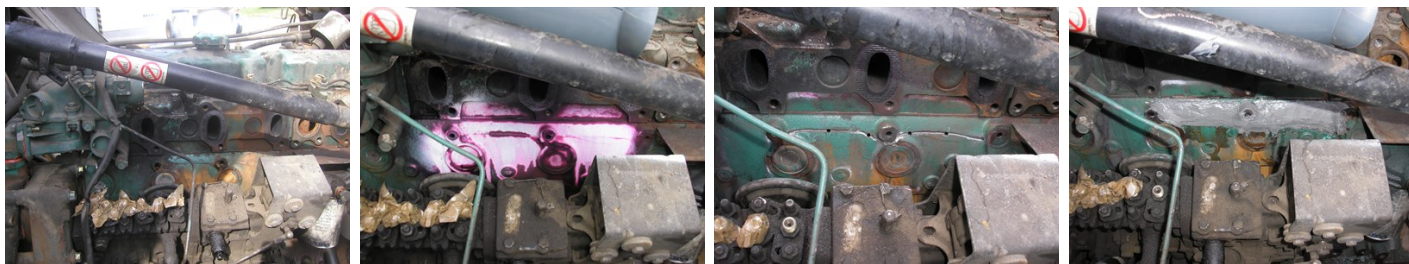
*Cracked block due to freezing over winter months.*

- \* 1. Cracked engine ,
- \* 2. Crack detection to identify all cracks ,
- \* 3. Surface preparation ,
- \* 4. Belzona 1111 repair incorporating Belzona 9341 Reinforcement Tape. ,

Application was carried out in accordance with Belzona Know-How System Leaflet ENC- 1

Welding of this damage would take a long time and potentially cause more damage so repairing with Belzona 1111 was much better for customer.
