BELZONA REPAIR TO CRACKED GLAND SEAL IN FOSSIL PLANT

ID: 76

Customer Location: Fossil Plant in Maryland
Application Date: October 1995

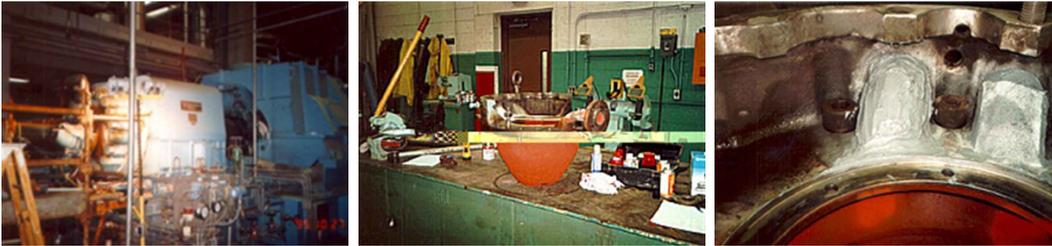
Gland seal had a cracked casing. The condensate used in the gland seal system was leaking and causing a safety problem.

- * Main Feed Pump - note rust around the gland ,
- * Casting on work bench prior to surface prep ,
- * Application of Belzona® 1111 ,

In accordance with Belzona Know-How Leaflet CEP-1.
