# BELZONA REPAIR TO CRACKED GLAND SEAL IN FOSSIL PLANT

ID: 76

Customer Location: Fossil Plant in Maryland  
Application Date: October 1995

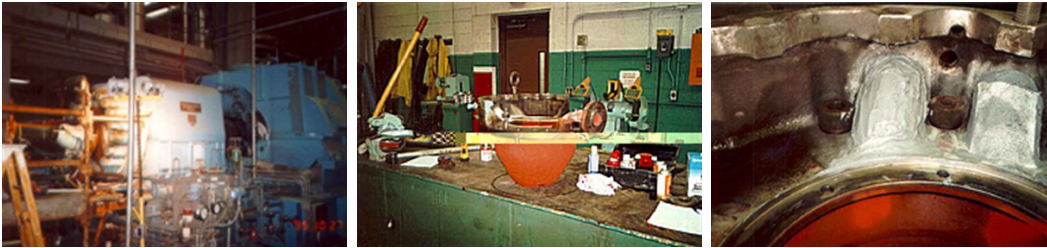
Gland seal had a cracked casing. The condensate used in the gland seal system was leaking and causing a safety problem.

- \* Main Feed Pump - note rust around the gland ,
- \* Casting on work bench prior to surface prep ,
- \* Application of Belzona® 1111 ,

In accordance with Belzona Know-How Leaflet CEP-1.
