BELZONA REPAIRS A GATE VALVE CRACK

Application: VPF-Valves, Pipes and Fittings

36" gate valve on a crane ship.

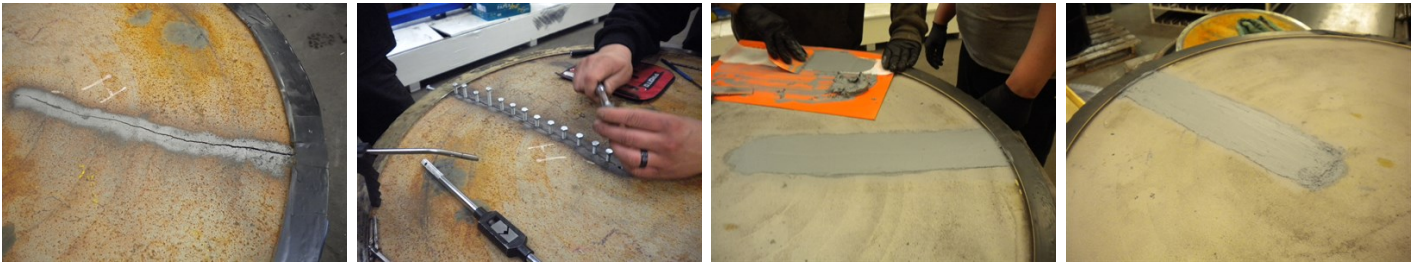
The disk of the gate valve had a large crack extending from the seat rings on the edge to the center of the disk.

- * 1. Crack in disk of gate valve ,
- * 2. Holes drilled, tapped and studs inserted. Crack terminated. ,
- * 3. Reinforcement sheet incorporated to add strength. ,
- * 4. Completed application. ,

The application was carried out in accordance with Belzona Know-How System Leaflet VPF-8. Procedure was followed out on both sides of the disk.

Due to the composition of the ductile iron welding would have been difficult. Welding also would have introduced heat stresses as well as the potential for galvanic corrosion. ABS approved this method to get the vessel back in water with minimal downtime.
