Belzona SuperWrap Allows Drilling to Continue

ID: 7630

Industry: Oil & Gas
Application: SOS-Ships and Offshore Structures

Customer Location: Azerbaijan
Application Date: November 2017

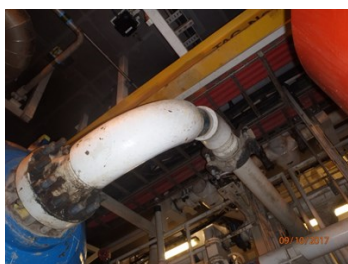
- * 1. View of Pipe before 21 wraps ,
- * 2. View of Pipe before 12 wraps ,
- * 3. View of SuperWrap repair: 21 wraps ,
- * 4. View of SuperWrap repair: 12 wraps ,

A platform off the coast of Baku had to stop drilling due to wall loss on the HP mud lines. The problem areas were on 3 bend sections.
