Transformer Damaged by a Forklift Repaired with Belzona

ID: 7672

Customer Location: *Oregon, USA*
Application Date: *January 3, 2018*

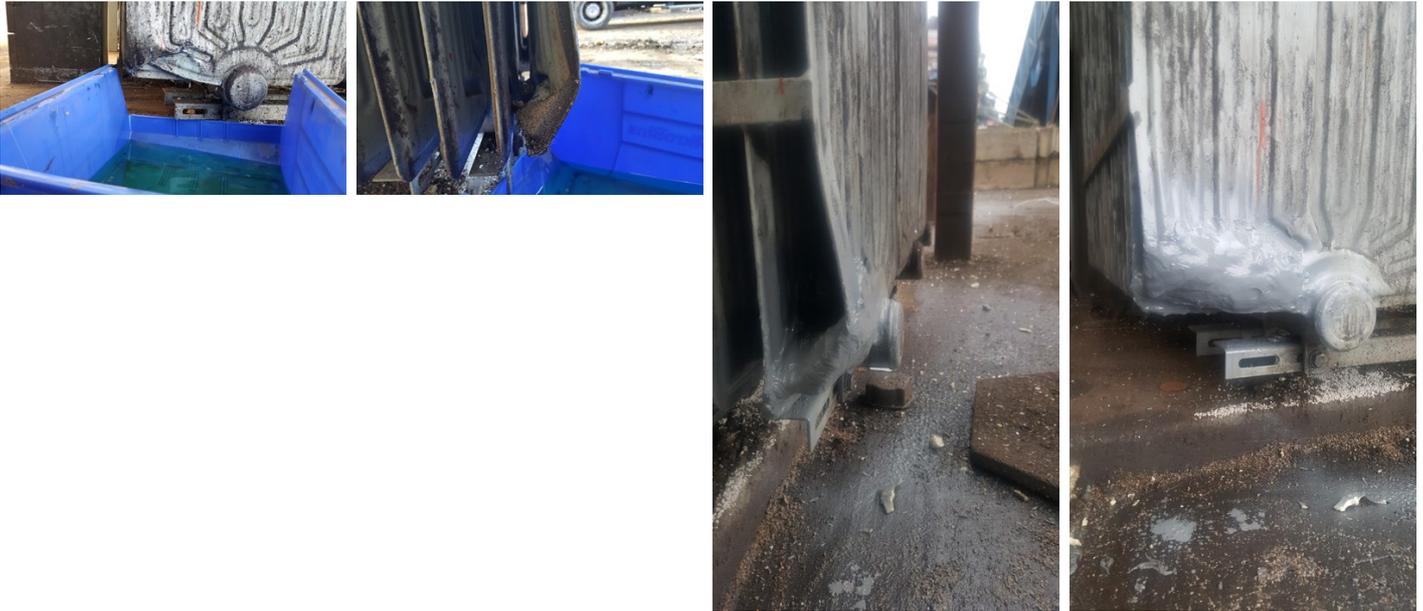
Forklift hit the cooling fins on an electrical transformer causing a serious oil leak.

- * 1. Note the oil dripping. ,
- * 2. Damage is severe, bending the cooling fin. ,
- * 3. & 4. Belzona 1212 applied, repair complete. ,

Electrical transformer cooling fin damaged by a forklift at a local recycling center.

The trained Belzona contractor received a call about a leaking transformer. The caller was happy to hear that Belzona would be used for the repair as they had been a Belzona user for some time. The contractor tried doing a live leak repair but the oil was coming out too fast. Next he hooked up a vacuum pump to the transformer pulling about -5 pounds. This stopped the oil flow, Belzona 1212 was applied for a permanent repair.

The only alternative would have been to drain the oil from the transformer and replace the cooling fin. Due to the age of the transformer a replacement was not likely.
