Transformer Damaged by a Forklift Repaired with Belzona

ID: 7672

Customer Location: *Oregon, USA*
Application Date: *January 3, 2018*

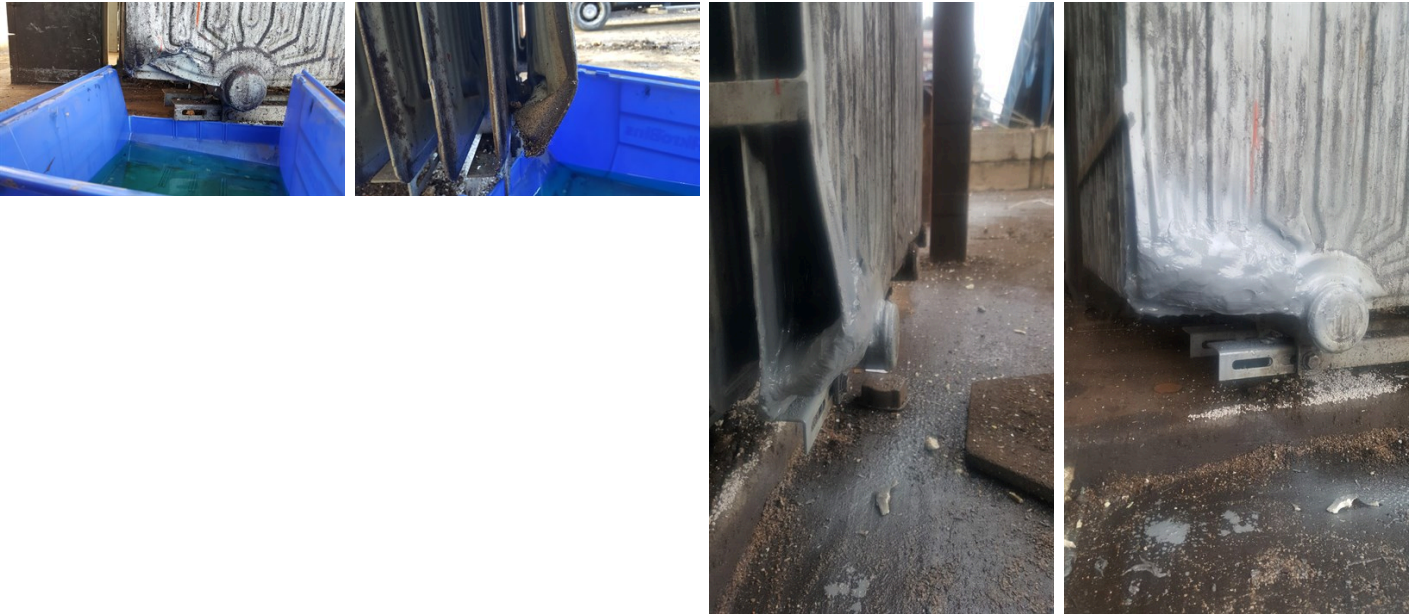
Forklift hit the cooling fins on an electrical transformer causing a serious oil leak.

- * 1. Note the oil dripping. ,
- * 2. Damage is severe, bending the cooling fin. ,
- * 3. & 4. Belzona 1212 applied, repair complete. ,

The trained Belzona contractor received a call about a leaking transformer. The caller was happy to hear that Belzona would be used for the repair as they had been a Belzona user for some time. The contractor tried doing a live leak repair but the oil was coming out too fast. Next he hooked up a vacuum pump to the transformer pulling about -5 pounds. This stopped the oil flow, Belzona 1212 was applied for a permanent repair.

The only alternative would have been to drain the oil from the transformer and replace the cooling fin. Due to the age of the transformer a replacement was not likely.
