Belzona 1311 Salvaged a Cracked Lining on a Valve

ID: 7794

Industry: Power
Application: GSS-Gaskets, Seals and Shims
Substrate: Mild Steel
Products: * Belzona 1311 ,

Customer Location: Ireland, UK
Application Date: September 2018

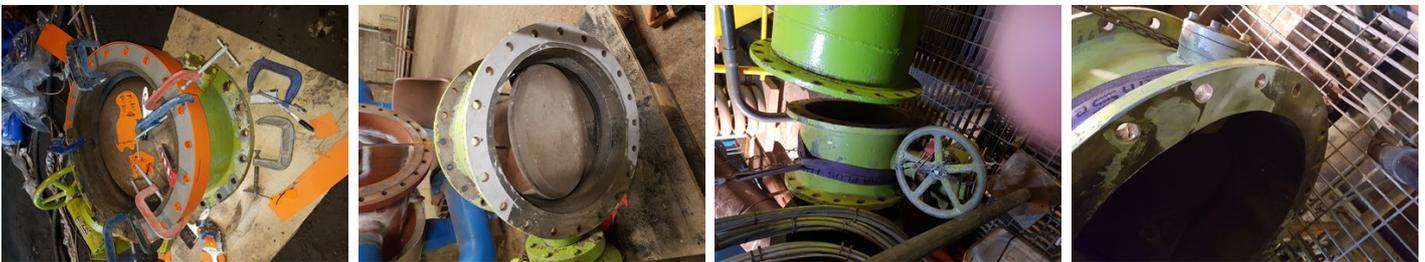
The ebonite lining on a valve from the auxillary cooling water system had cracked and failed around the valve flange

- * Substrate blasted and formers in position. ,
- * Repaired vlave ready to be installed. ,
- * Valve being installed. ,

The damaged ebonite liner was removed. The exposed steel was washed and grit blasted. Using a modified version of Belzona Know-How System leaflet GSS-10, formers were made from Belzona working surfaces and clamped into position. Belzona 1311 was applied and following curing the formers were removed.
