Belzona Remedies Damage Caused by a Broken Piston Rod

ID: 7822

Industry: General Industry
Application: ENC-Engines and Casings
Substrate: Cast Iron
Products: * Belzona 1111 (Super Metal) ,

Customer Location: Egypt
Application Date: April 2003

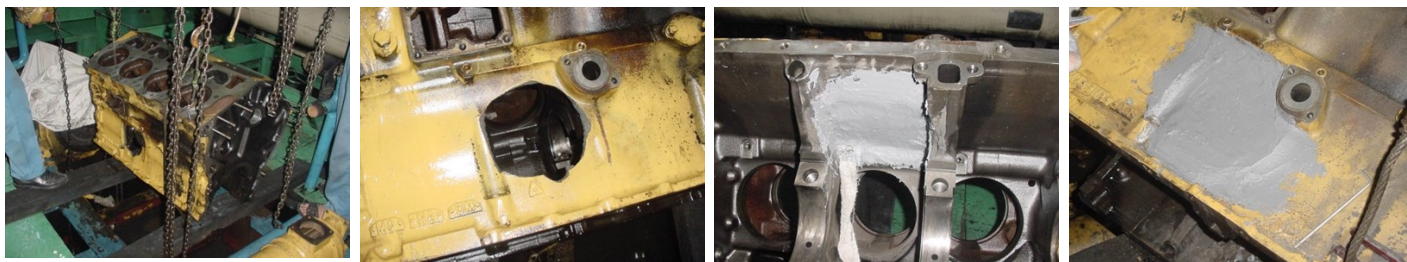
A broken piston rod had caused damage to the engine casing, resulting in a large hole.

- * Engine block removed and hoisted into position ,
- * Close up of the defect ,
- * Plate bonding with Belzona 1111 ,
- * Completed application ,

The engine functions as a propulsion system for a ship. As the engine room is a confined space with limited access, removing and replacing the engine casing was not only expensive, but logistically difficult. Welding repairs are also undesirable due to risk of fire in the engine room. Belzona was selected to carry out a cold cured repair in-situ, overall reducing the cost, down time and safety risk of the repair.
