Belzona Remedies Damage Caused by a Broken Piston Rod

ID: 7822

Industry: *General Industry*
Application: *ENC-Engines and Casings*
Substrate: *Cast Iron*
Products: ** Belzona 1111 (Super Metal) ,*

Customer Location: *Egypt*
Application Date: *April 2003*

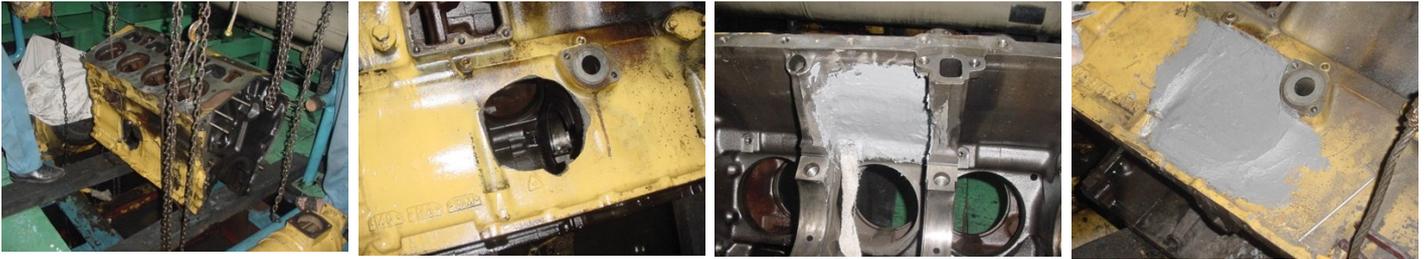
A broken piston rod had caused damage to the engine casing, resulting in a large hole.

- * Engine block removed and hoisted into position ,
- * Close up of the defect ,
- * Plate bonding with Belzona 1111 ,
- * Completed application ,

The engine functions as a propulsion system for a ship. As the engine room is a confined space with limited access, removing and replacing the engine casing was not only expensive, but logistically difficult. Welding repairs are also undesirable due to risk of fire in the engine room. Belzona was selected to carry out a cold cured repair in-situ, overall reducing the cost, down time and safety risk of the repair.
