Belzona Repairs Grayloc Flange Damage in Water Injection Line

Customer Location: Ghana, FPSO
Application Date: March 2019

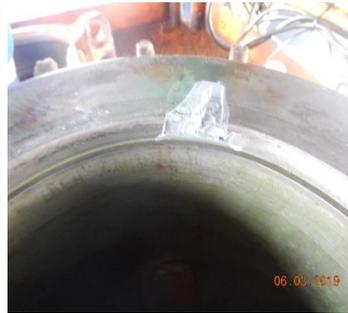
The topside end fitting connection joint on the riser used a Grayloc system to contain the high pressure. Due to a material defect a small area on the gasket had worn away, causing a leak.

The application was carried out in accordance with Belzona System Leaflet VPF-13. After the Belzona 1111 was applied, a fine grain abrasive paper was used to achieve a smooth and level finish.
