# Belzona Chocking Repair on Gear Mounting

ID: 8061

Application: GSS-Gaskets, Seals and Shims

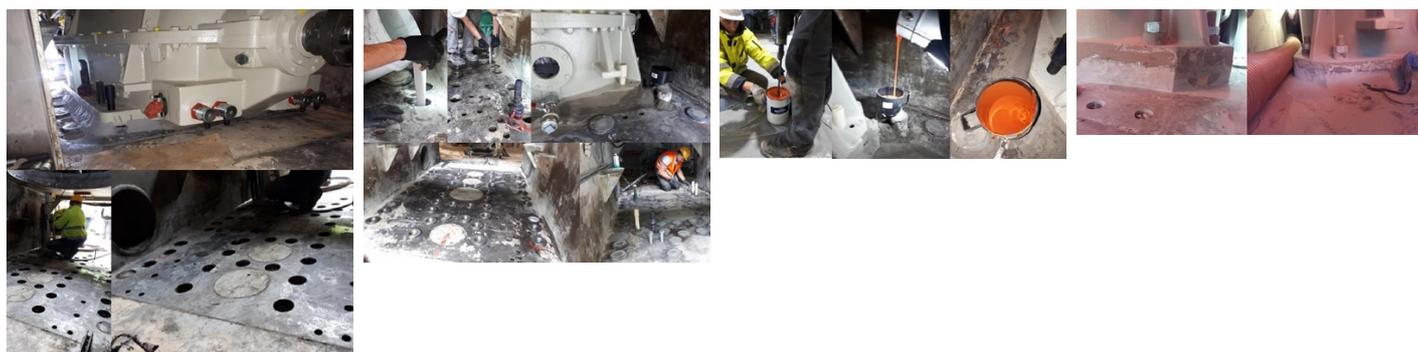
Gear mounting not working at full efficiency due to misalignment. Repair work need to concrete area prior to chocking.

- \* 1. Gear Equipment Picture ,
- \* 2. Application of Belzona 4111 ,
- \* 3. Application of Belzona 7111 ,
- \* 4. Chocking application complete. ,

Re-levelling a steel foundation slab of a mill gear and the foundation of the mill on the plate.

The application was carried out in accordance with Belzona System Leaflet GSS-2. Placing of the steel foundation slab using the Belzona 4111. Chocking the foundation of the mill plate using Belzona 7111.
