Belzona Repairs Fertilizer Tank

ID: 8082

Repair of a tank used for fertilizer production.

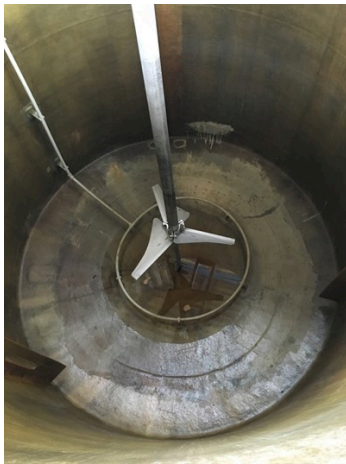
An existing fiberglass lining had failed at the bottom of the tank due to not having the correct chemical resistance for the range of chemical circulating the tank. The failed lining resulted in a loss of material at the base of the tank and also leaving the substrate unprotected and exposed to further chemical attack.

- * 1. Failed fiberglass lining due to chemical attack ,
- * 2. Rebuilding with Belzona 1111 ,
- * 3. First coat of Belzona 4311 ,
- * 4. Finished application ,

This application was carried out in accordance with system leaflet TCC-03. The fiberglass coating was removed and the substrate was blasted to SA 2.5 before rebuilding the lost profile with Belzona 1111. Belzona 4911 was used to condition the surface before 2 coats of Belzona 4311 were applied to prevent future chemical attack from occurring.

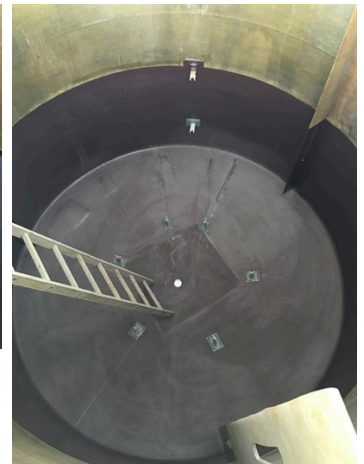
This is a regular customer of the distributor and the tank was inspected 4 years later and was still in good working service.
