Belzona Repairs Fertilizer Tank

ID: 8082

Repair of a tank used for fertilizer production.

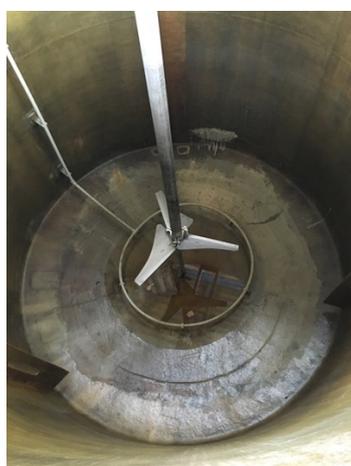
An existing fiberglass lining had failed at the bottom of the tank due to not having the correct chemical resistance for the range of chemical circulating the tank. The failed lining resulted in a loss of material at the base of the tank and also leaving the substrate unprotected and exposed to further chemical attack.

- * 1. Failed fiberglass lining due to chemical attack ,
- * 2. Rebuilding with Belzona 1111 ,
- * 3. First coat of Belzona 4311 ,
- * 4. Finished application ,

This application was carried out in accordance with system leaflet TCC-03. The fiberglass coating was removed and the substrate was blasted to SA 2.5 before rebuilding the lost profile with Belzona 1111. Belzona 4911 was used to condition the surface before 2 coats of Belzona 4311 were applied to prevent future chemical attack from occurring.
